Full scale cast iron girders reinforced with CFRP - flexural testing

Professor Stuart Moy

Breich Bridge, layout – built 1869

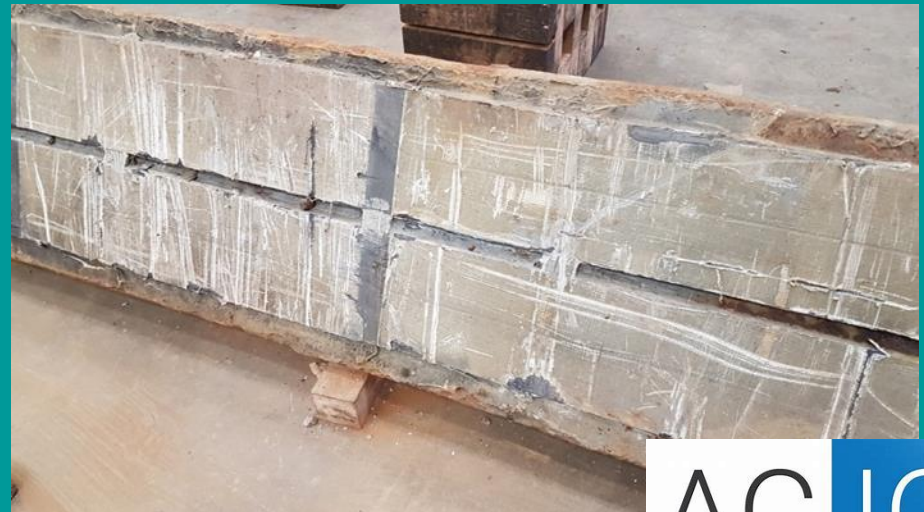
Cast iron girders in the laboratory

Left hand girder – CFRP damaged, cut across to be ineffective.

Note remains of jack arch

Right hand girder – CFRP in good condition.
CFRP consisted of parallel plates, 200mm wide. Each plate had three 4.7mm thick prepreg UHM layers. All bonded with epoxy.

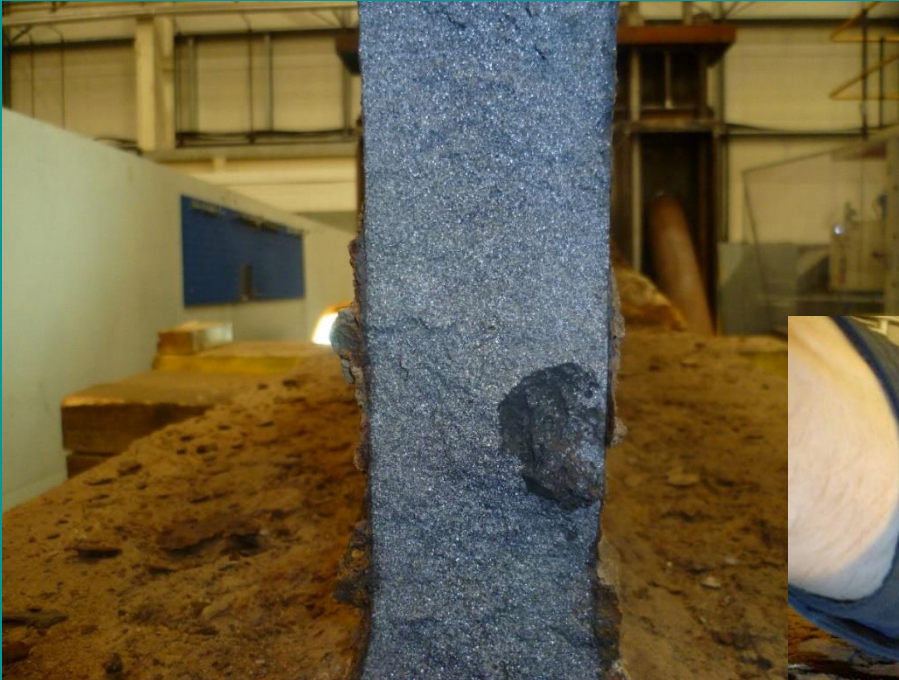
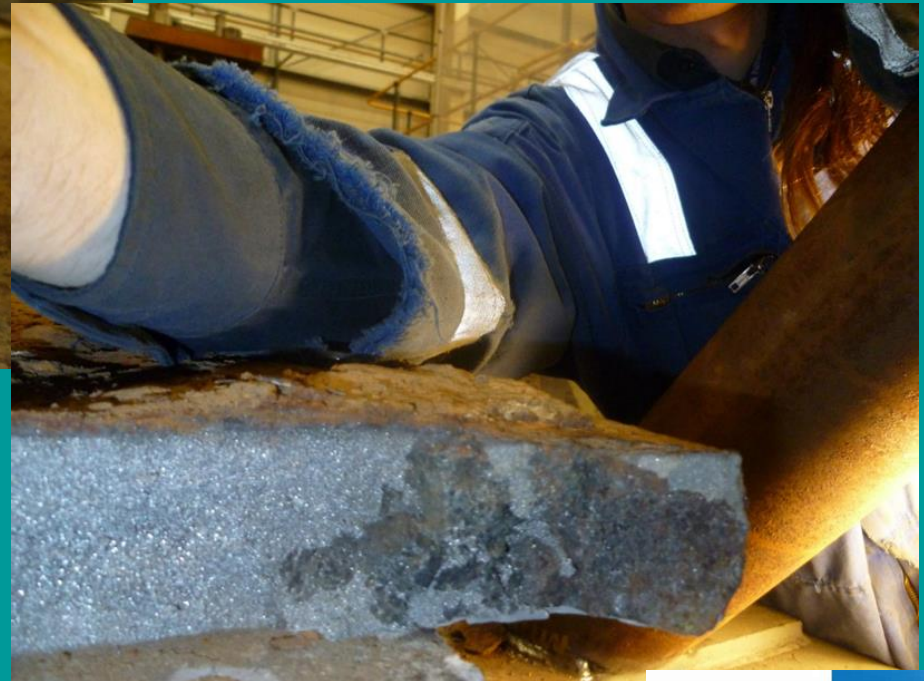
Failure of girder 1, unreinforced

- Unreinforced girder failed at end of constant moment length
- Typical failure surfaces for old cast iron

- Note the large slag inclusions in both web and flange
- Failure was instantaneous, running up from the tension flange
- Failure load 674.6kN, failure stress 104N/mm²

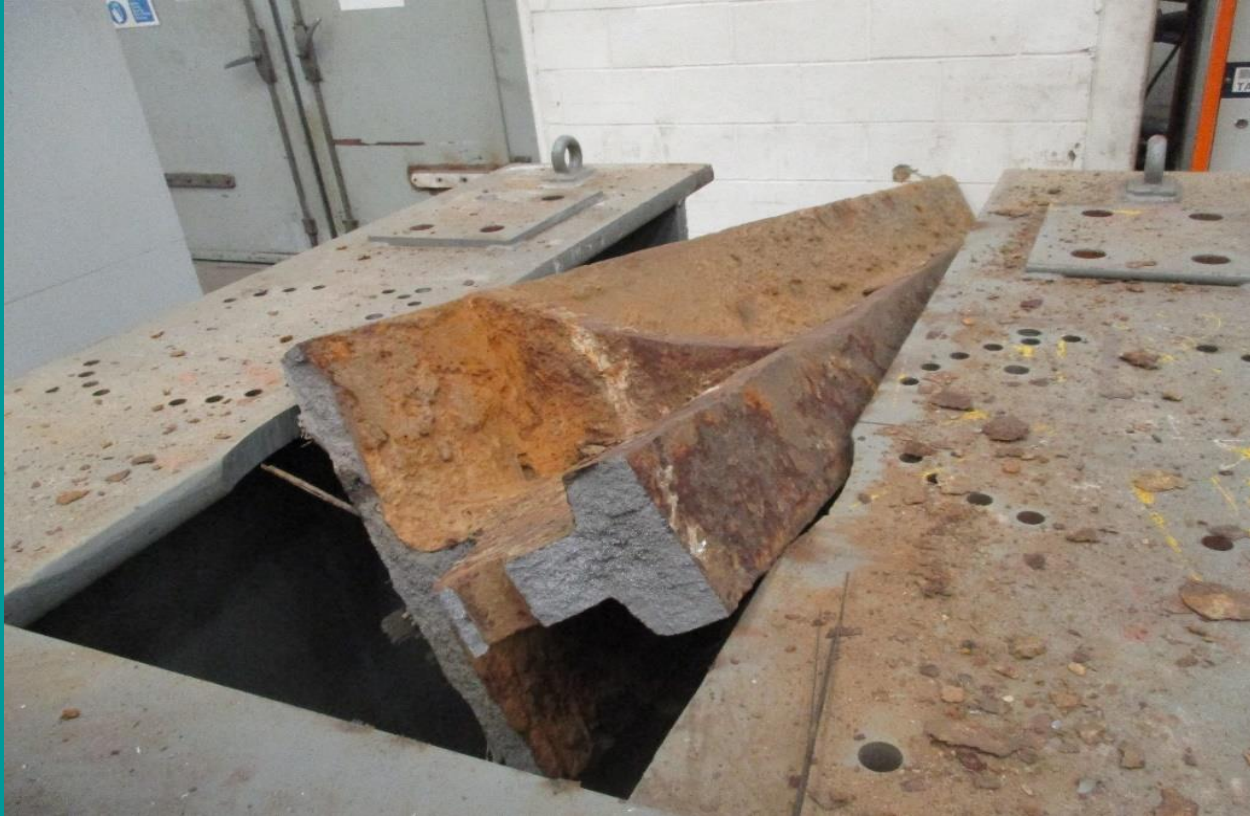
Failure of girder 2, reinforced

Failure was catastrophic, this fragment weighing about 1.5 tonnes jumped off the test rig. Testing cast iron is dangerous

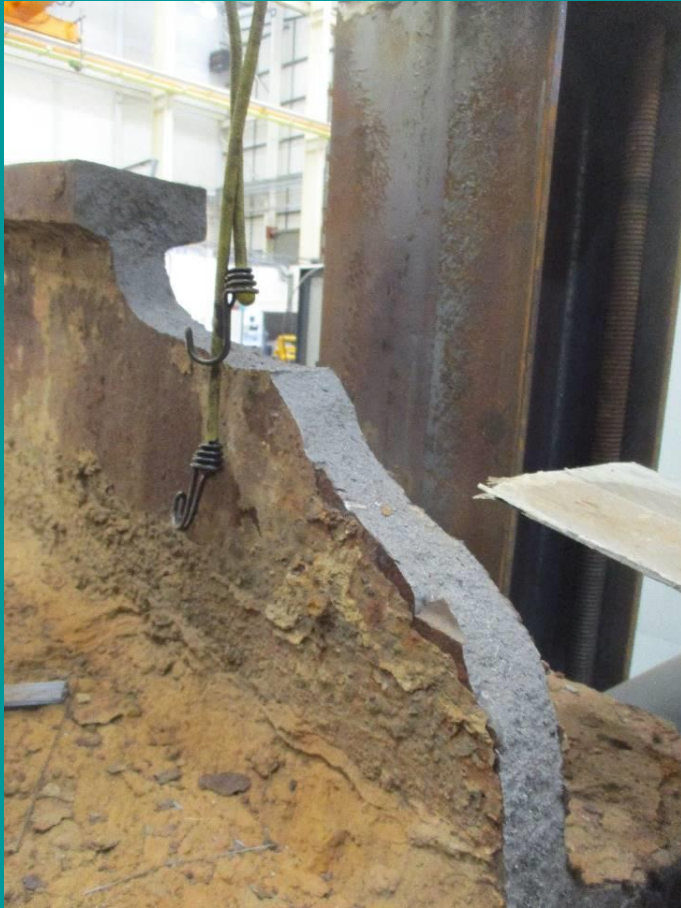
Failure of girder 2, reinforced

- Failure occurred just outside the constant moment length, combination of high BM and SF. Hence the inclined failure surface
- Texture of the failure surface is typical
- There was warning of failure, noises from localised debonding of CFRP

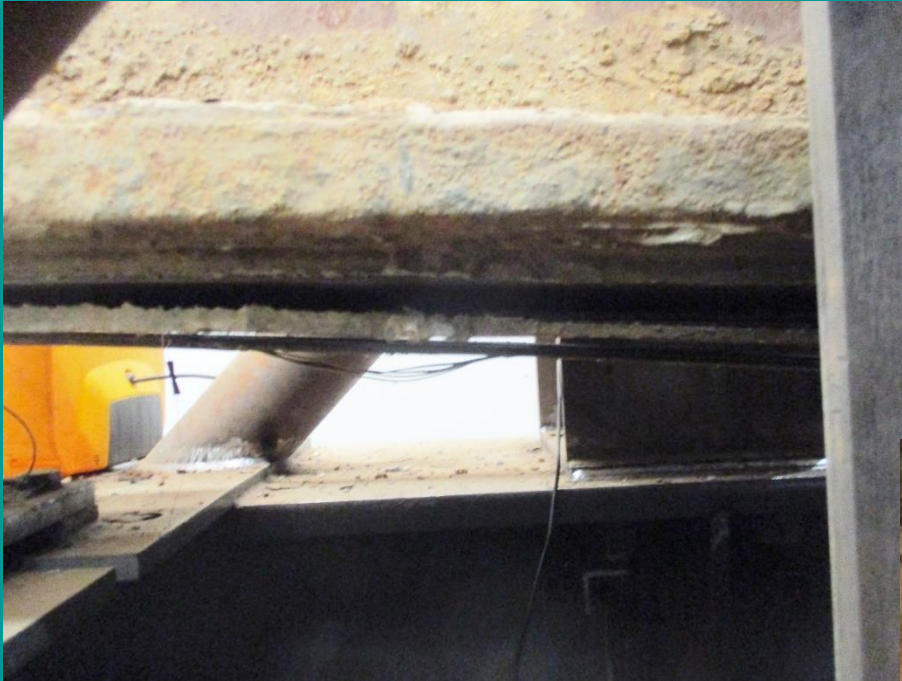
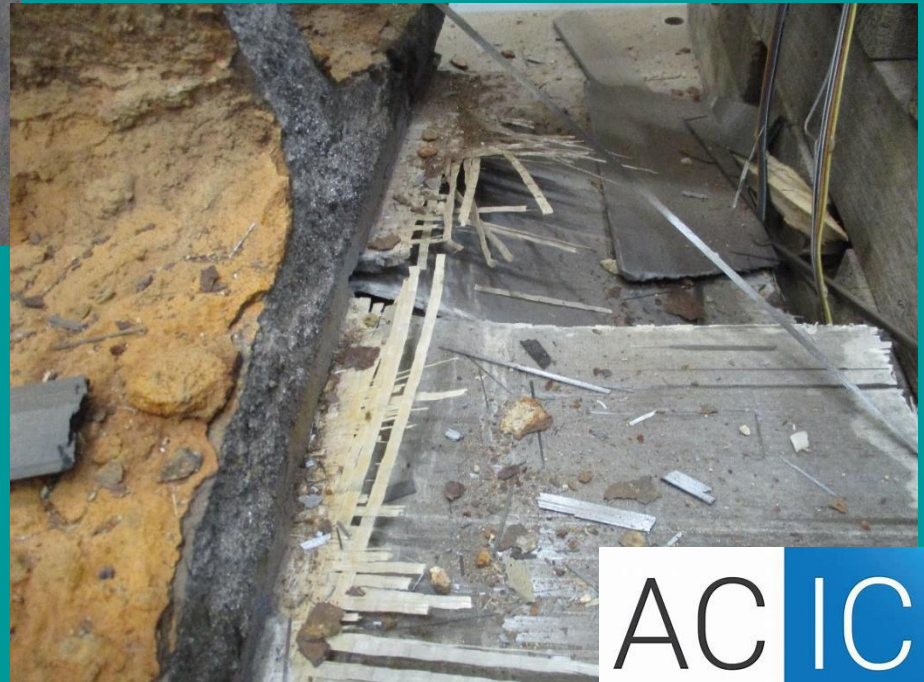
Failure of girder 2, reinforced

Outer 4.7mm thick layer of CFRP debonded and broke at about 680kN load

- Complete failure occurred at 970.6kN
- CFRP ruptured and the cast iron broke in two
- Note the GFRP layer

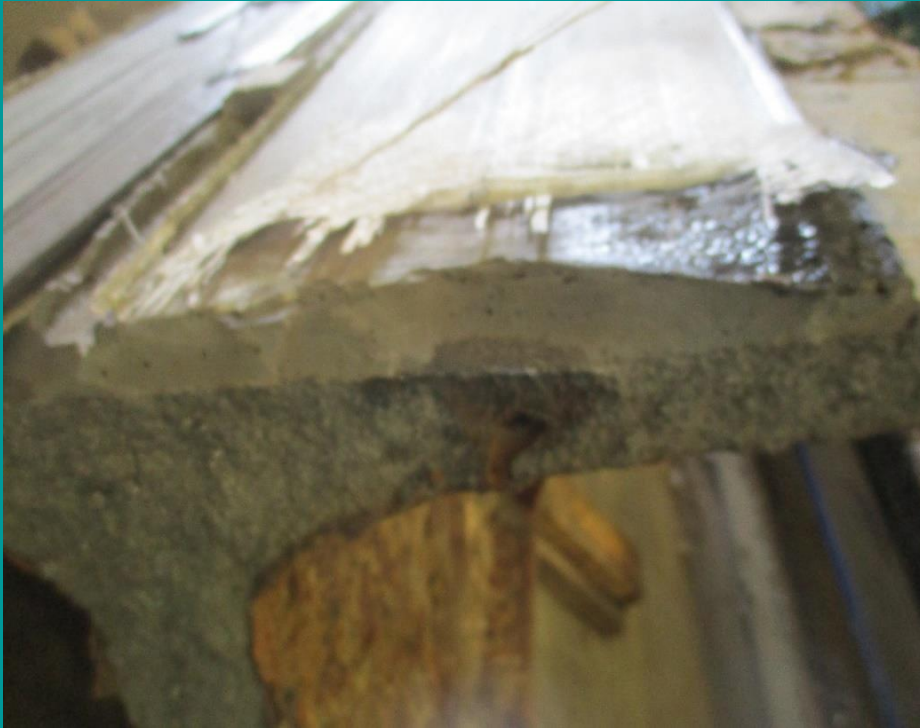
Failure of girder 2, reinforced

- What was unexpected was the 20mm thick adhesive on the failed flange.
- Note also the slag inclusion and the reduced flange thickness

- The explanation came from Tony Gee and Partners the designers of the strengthening scheme.
- The steam from early locomotives was acidic and eroded the metal locally
