Direct Service Temperature Exposure Effect on Bond Behaviour between NSM Composites and Concrete Masonry Units

**Zuhair Al-Jaberi
John J. Myers
and
Chandrashekhara, K**

**Presented by:
Prof. Dr. John J. Myers**

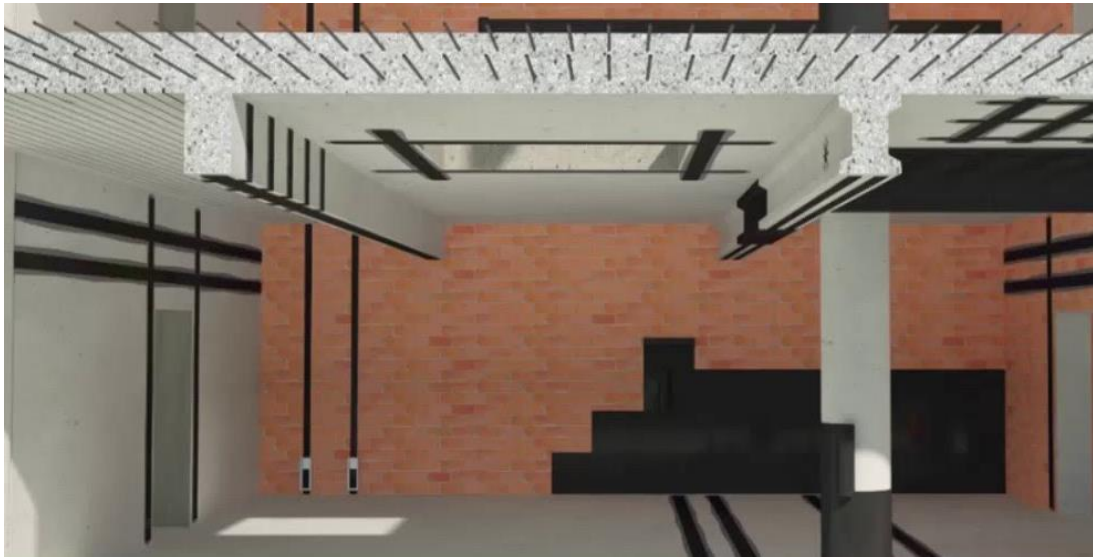
The interest in advanced composites in repairing and strengthening infrastructure systems has considerably increased, especially when the application of fiber reinforced polymer (FRP) has become more established.

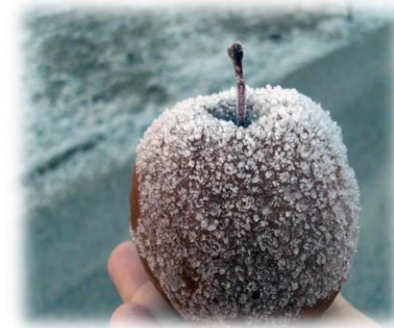
> The main environmental degradation factors that can affect the behavior of strengthened walls are:

- Freeze and thaw,
- Temperature, and
- Moisture

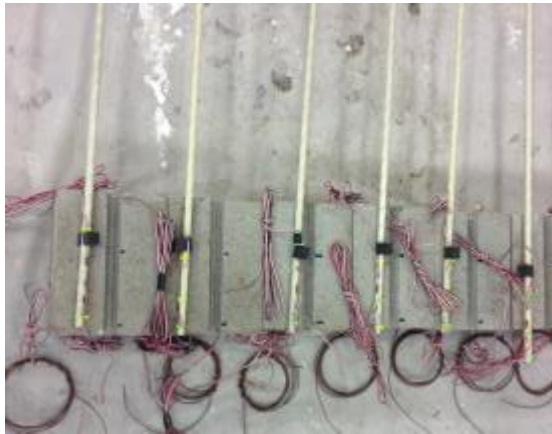
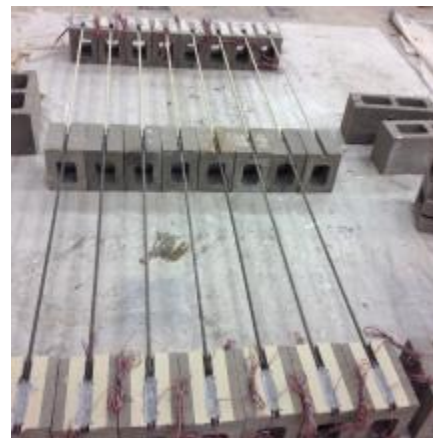
No surface preparation was needed for the NSM system, and the strengthening procedure involved inserting FRP bar into a groove cut at the surface of the specimen. A grinder with a diamond concrete blade was used to cut the groove with a dimension double the diameter of the bar to avoid splitting failure of the adhesive cover.

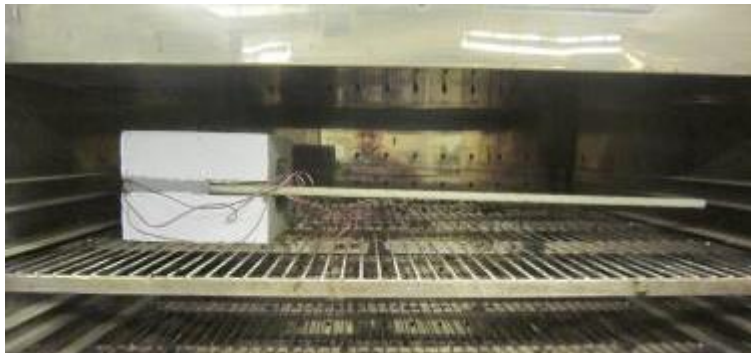
Specimens were preconditioned, heated up to 49°C (120°F) in a furnace or cooled down to -18°C (0°F) in a refrigerator, and then the specimens were immediately brought to the chamber that was attached to the MTS universal testing machine to ensure that the specimens were at temporal with desired temperature.

Specimen in furnace

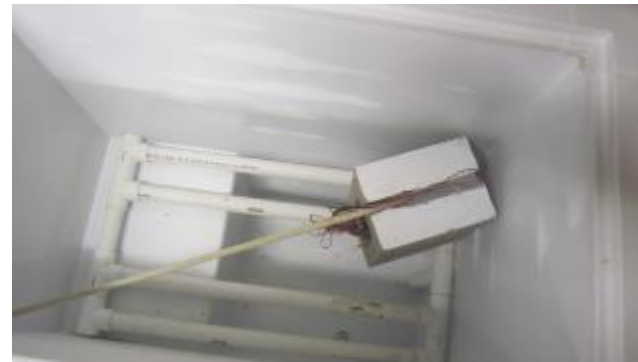
Specimen in refrigerator

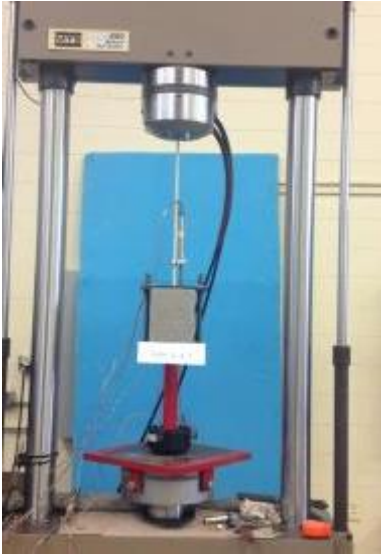
MTS universal testing machine

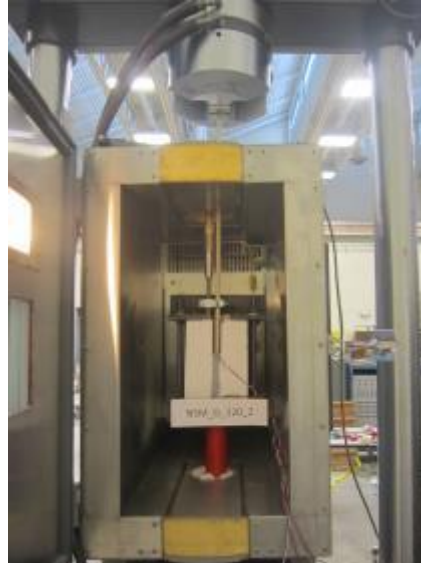
Chamber attached to the MTS machine

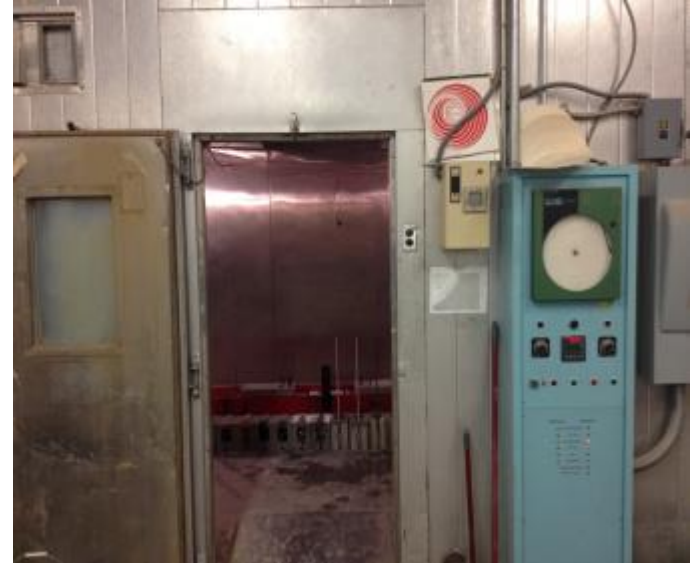
Environmental chamber

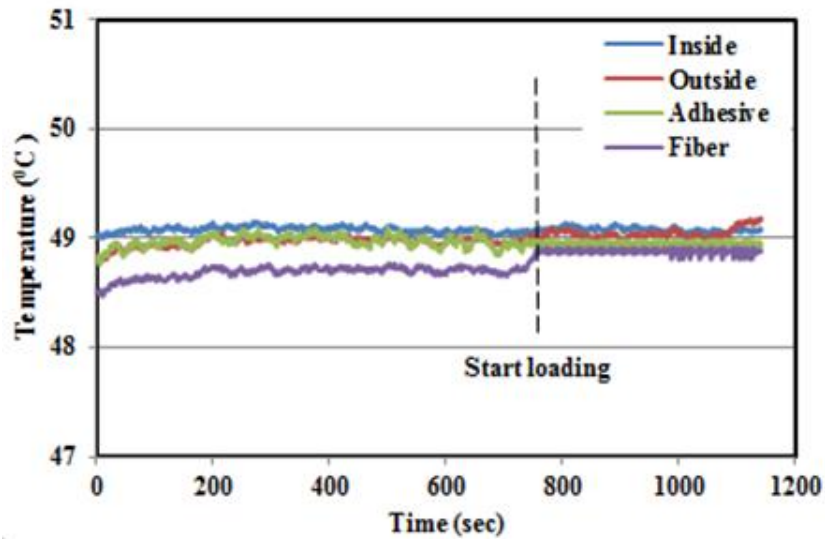
Four thermocouples reading

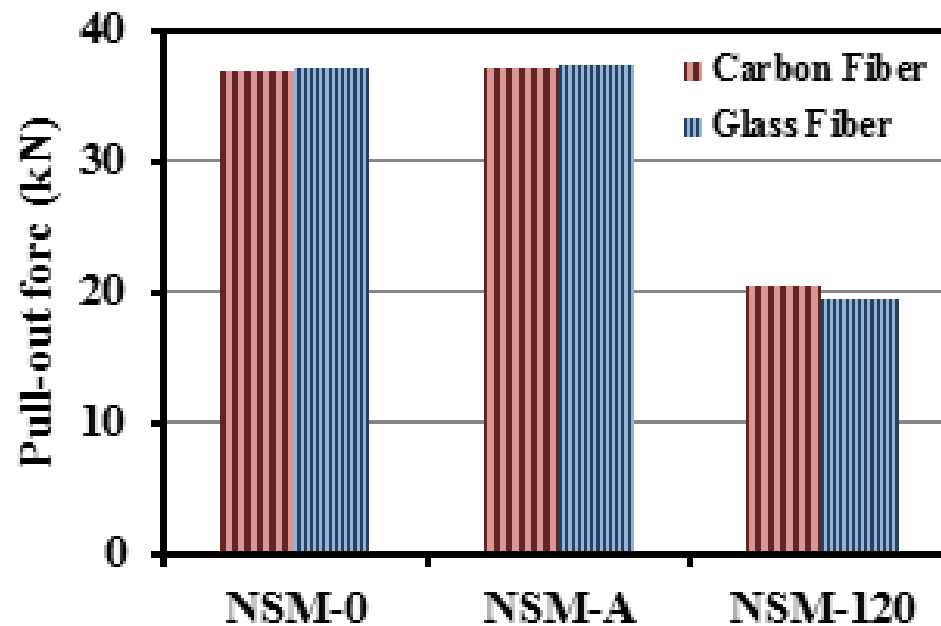
The decrease of the ultimate pull-out force can be observed for temperatures close to the heat distortion temperature (HDT).
