Full scale cast iron girders reinforced with CFRP - flexural testing

Professor Stuart Moy

Breich Bridge, layout – built 1869

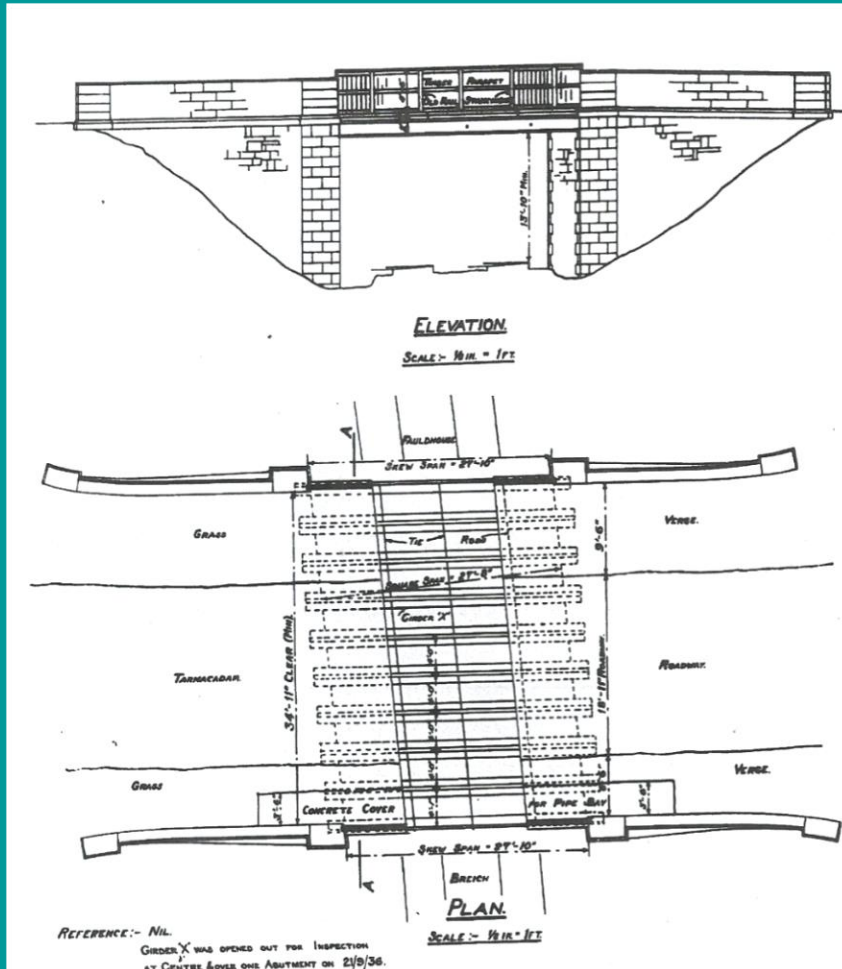
- Line between Glasgow and Edinburgh, Scotland
- Cast iron girders 9m long, 8.5m clear span. Concrete jack arches between
- Reinforced with CFRP in 2004
- Demolished due to electrification
- 2no. Girders removed almost intact

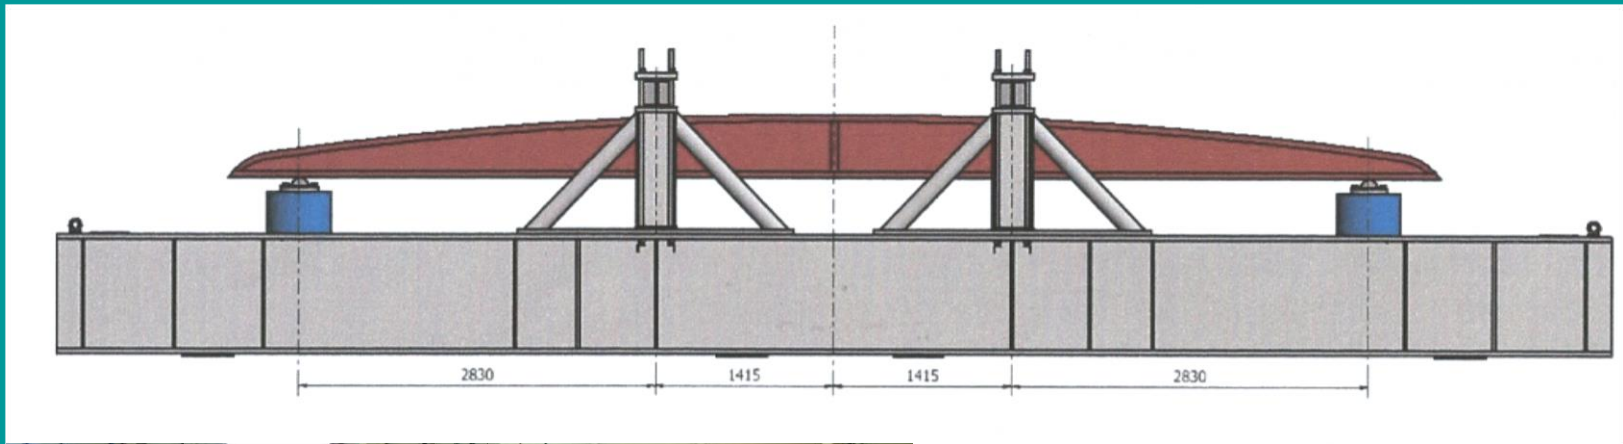
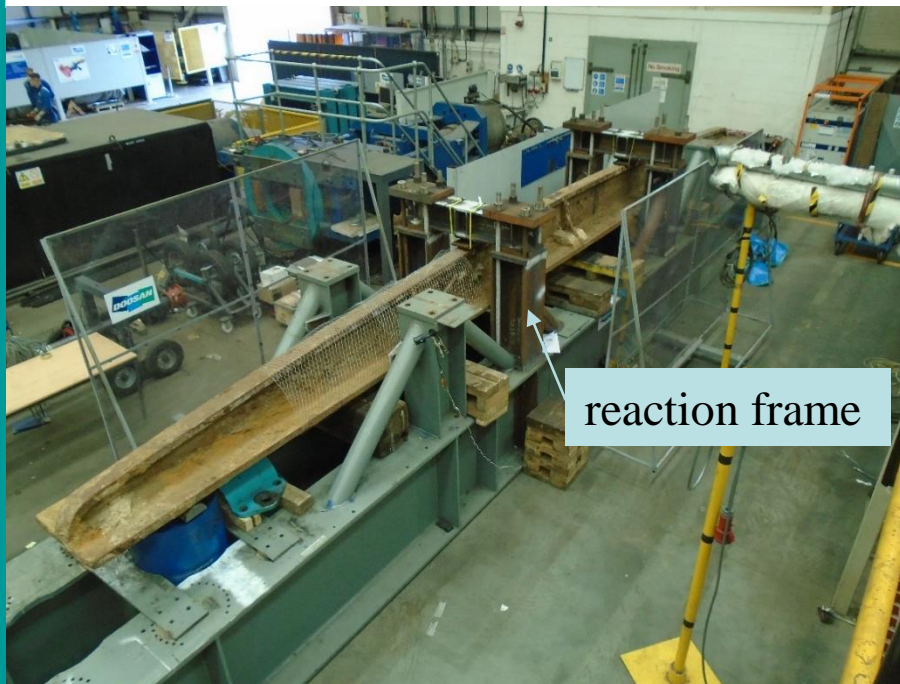
Schematic of test rig and photo of girder in the rig

Test rig applied load through jacks at each end. Loads reacted at third points. Set-up not ideal, reaction frames deflected under load and displacement measurement difficult

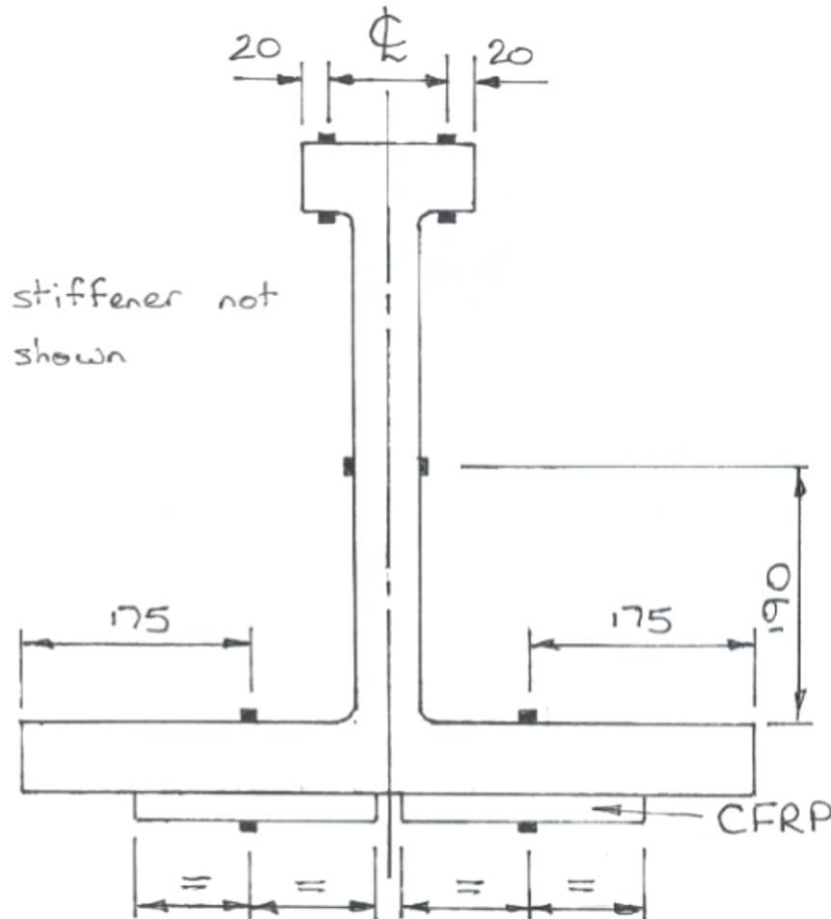
Strain gauge locations near midspan

All gauges 30mm gauge length
Located just to left of centreline to avoid stiffener

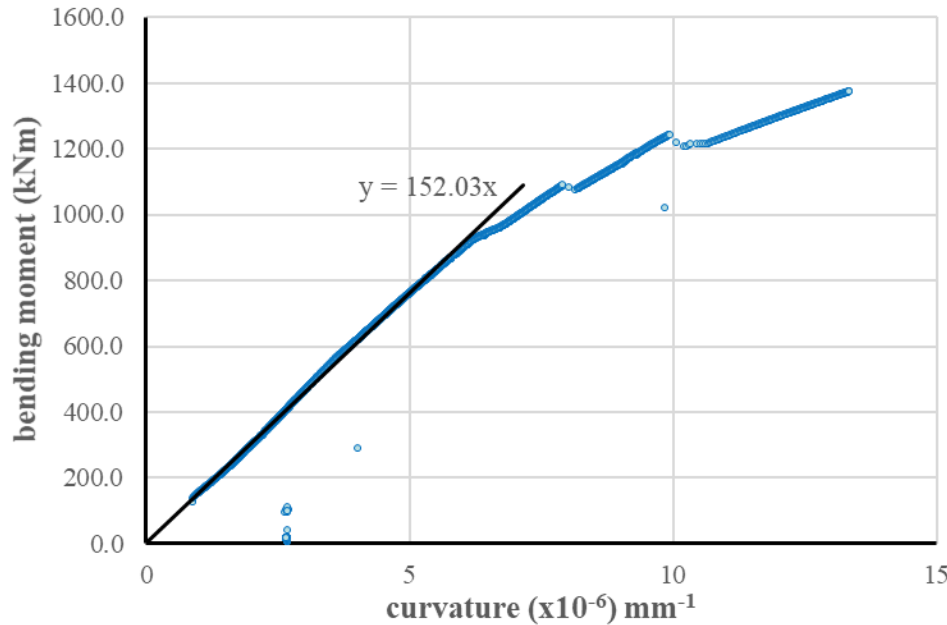
Moment-curvature relationship, reinforced girder

- Moment-curvature relationship for girder 2, calculated from strain gauge readings
- Table shows how stiffness reduced with increasing load
- The equivalent I values agree closely with calculated values

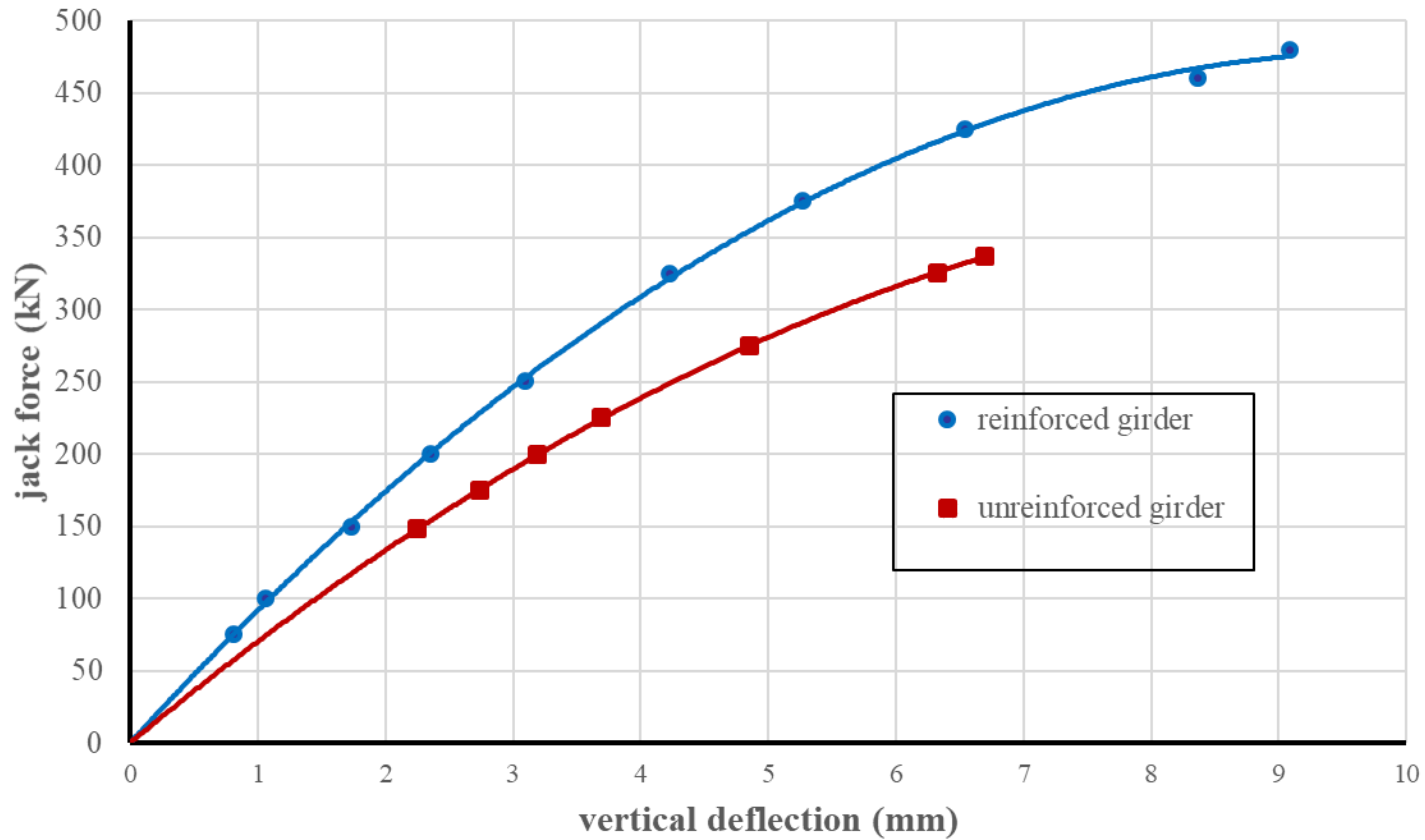
Selected results – maximum flexural displacements in middle third of girders

1. Testing at full scale demonstrated the effectiveness of CFRP strengthening of metallic structures
2. The girder reinforced with CFRP carried 43.9% more load than the unreinforced girder
3. Comparing effective 'I' values, the reinforced girder was 30.7% stiffer than the unreinforced girder
4. The CFRP strengthening was applied 12 years before the bridge was demolished and was still working as intended. This gives some confidence in the long term effectiveness of the technique
5. One note of caution, the results were based on single tests and cast iron is a notoriously variable material! I'm told that other girders were removed intact but Network Rail haven't taken my hints!
